Manhole Inspection Summary

Manhole # S45A__038MH

Insp Date: **3/9/10 11:40 AM**

Location Address: **Orleans**

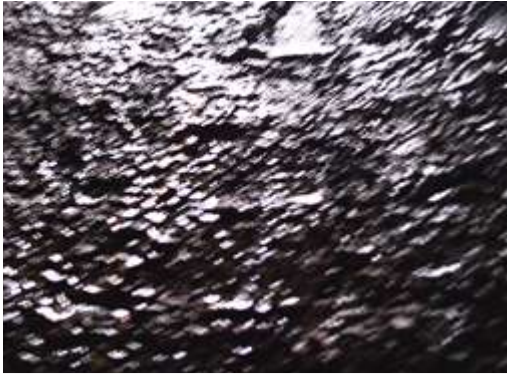
Defect 2

Frame Offset: **1** (in.) Condition: ☐ Sound ☐ Cracked ☒ **Leaks**

infiltration

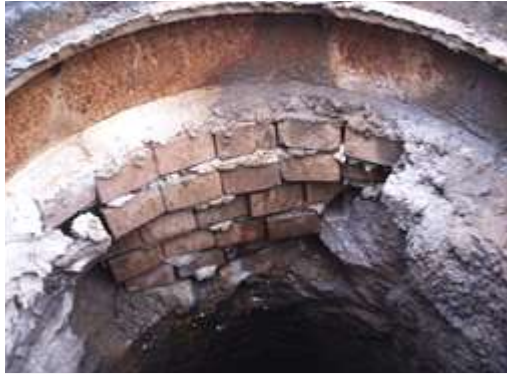
Defect 1

Condition: ☐ Sound ☒ **Cracked** ☐ Root Intrusion ☒ **Loose Brick** ☒ **Deteriorated**

loose bricks

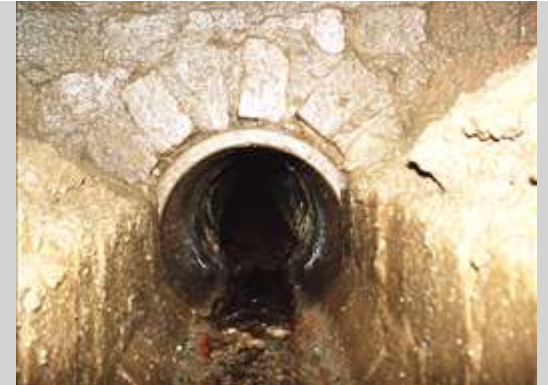
12 O'Clock Outflow

8 in. Circular Gravity Sewer
Pipe Out @ 12 O'Clock

Pipe Height: **14.4** (in.) Rod and Bar (Angled)
Pipe Material: **Clay** ☐ Pipe Lined
Invert Depth: **12.00** (ft.) Flow Characteristics: **Slow**
Deposits: ☒ None ☐ Mud ☐ Sludge ☐ Debris ☐ Grease
Silt Depth: (in.) Deposits Extent:
Infiltration: **None** Pipe Seal Cond: **Sound**

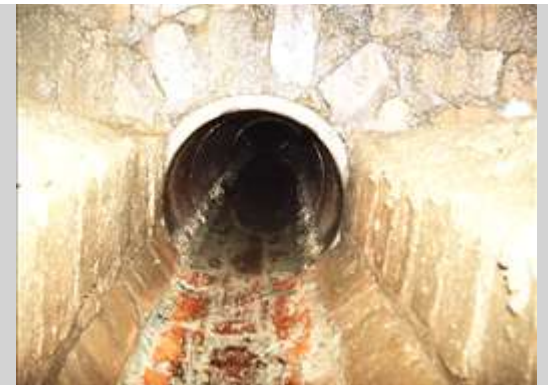
6 O'Clock Inflow

8 in. Circular Gravity Sewer
Pipe In @ 6 O'Clock

Pipe Height: **13.2** (in.) Rod and Bar (Angled)
Pipe Material: **Clay** ☐ Pipe Lined
Invert Depth: **11.92** (ft.) Flow Characteristics: **Slow**
Deposits: ☒ None ☐ Mud ☐ Sludge ☐ Debris ☐ Grease
Silt Depth: (in.) Deposits Extent:
Infiltration: **None** Pipe Seal Cond: **Sound**
